Town of Chili Parks and Recreation Master Plan Update

APPENDIX C: BUILDING CONDITION SURVEYS

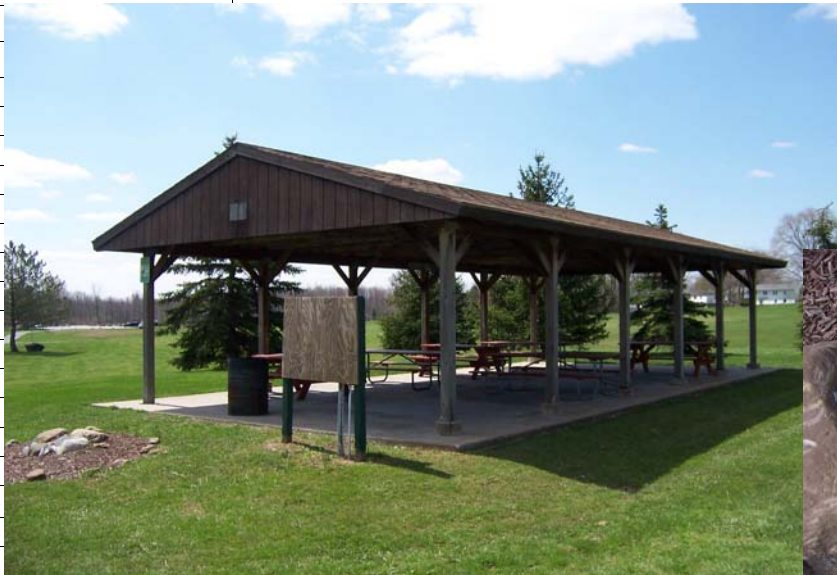
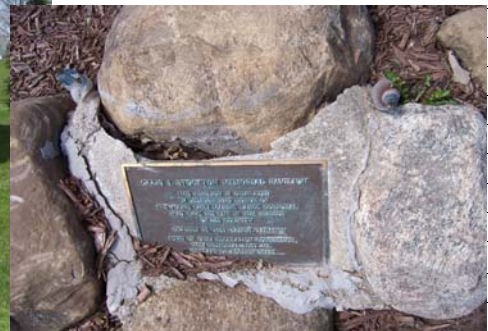
Date	4/25/2013
Park	Davis
Structure	Pavilion
Year constructed	
Arch. significant	NA
No. of stories	One
Sprinklers	NA
Gross SF +/-	
Plans available	No
Exterior wall type	None
Structural system	Wood posts with prefab wood trusses - fair to good
Found. / floor slab	Concrete floor - good condition; Bases for columns all are cracking, one is completely gone, another is breaking apart
Roof	Asphalt shingles; will require reroofing in about 5 years.
Soffits / cornice	Wood stained, all should be restrained including wood siding at pediment with opaque stain
Interior finishes	NA
Plumbing	NA
HVAC	NA
Electrical	Mounted on a board outside the pavilion
Stairs and railings	NA
Doors	NA
Windows	NA
Chimneys	NA
Energy utilization	Limited to electric; seasonal
Handicapped access	Good, from parking over lawn, no walkway fairly level
Toilet facilities	At sessions building which is nearby
General repair notes	Needs standard maintenance

Condition rating	fair to good
Proposed improvement	Stain all wood components to freshen up appearance
	Repair broken or missing concrete bases at columns
	Provide a more substantial stone and mount memorial plaque on it

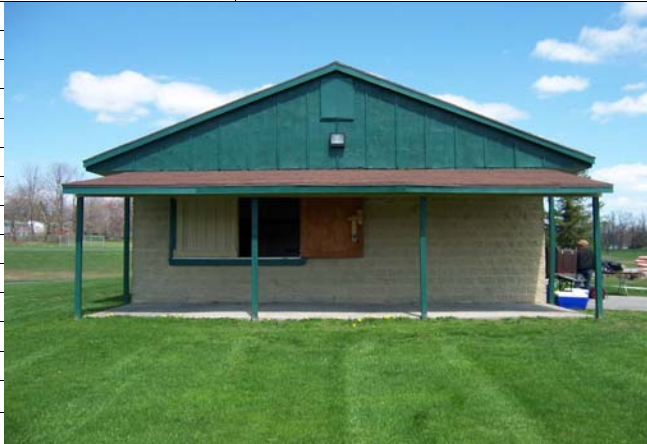
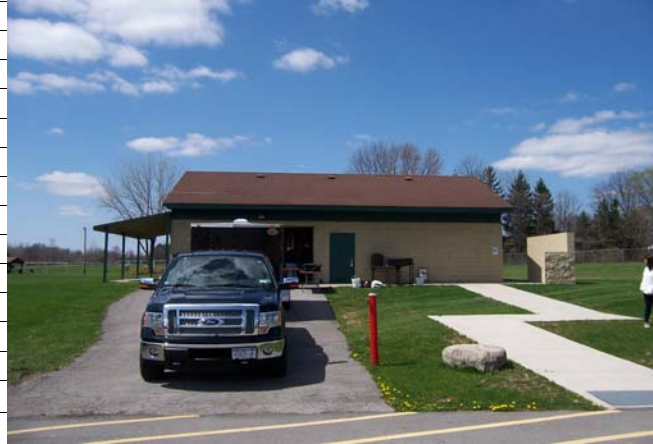
Date	4/25/2013
Park	Davis Park
Structure	Concessions and Toilet Building
Year constructed	
Arch. significant	NA
No. of stories	One
Sprinklers	NA
Gross SF +/-	
Plans available	Possible need to verify
Exterior wall type	Split face masonry block painted; no insulation (assumed)
Structural system	Masonry block with wood trusses
Found. / floor slab	Concrete floor; painted in toilet rooms; concrete slab at concessions
Roof	Asphalt shingles; Shingles are missing and need to be replaced. Assume roof replacement in 5 +/- years
Soffits / cornice	Wood painted
Interior finishes	Painted block. Toilets have new FRP wall panels; painted plywood ceilings with grid.
Plumbing	Yes. Toilet fixtures are all new and handicapped accessible.
HVAC	Propane tank for equipment located outside in locked storage; No heat or AC
Electrical	Yes. Door actuators at toilet doors.
Stairs and railings	NA
Doors	Metal painted
Windows	Concessions service counter window shutter is wood and awkward to use. There is a coiling shutter on the inside.

Chimneys	NA
Energy utilization	Limited; seasonal
Handicapped access	Yes
Toilet facilities	Toilet rooms have been renovated within the last year, excellent condition!
Kitchen Equipment	one stove with flat griddle, one three bay sink, one hand sink, two res. exhaust hood; one ref.
General repair notes	Replace missing shingles, power wash kitchen floor Replace shutter at window
Condition rating	Fair
Proposed improvement	Replace missing shingles Replace concessions counter window shutter. At present the kitchen equipment is not up to code, so it could remain as is until major repairs are made. (Commercial exhaust hood, need two bay sink, grease trap?)

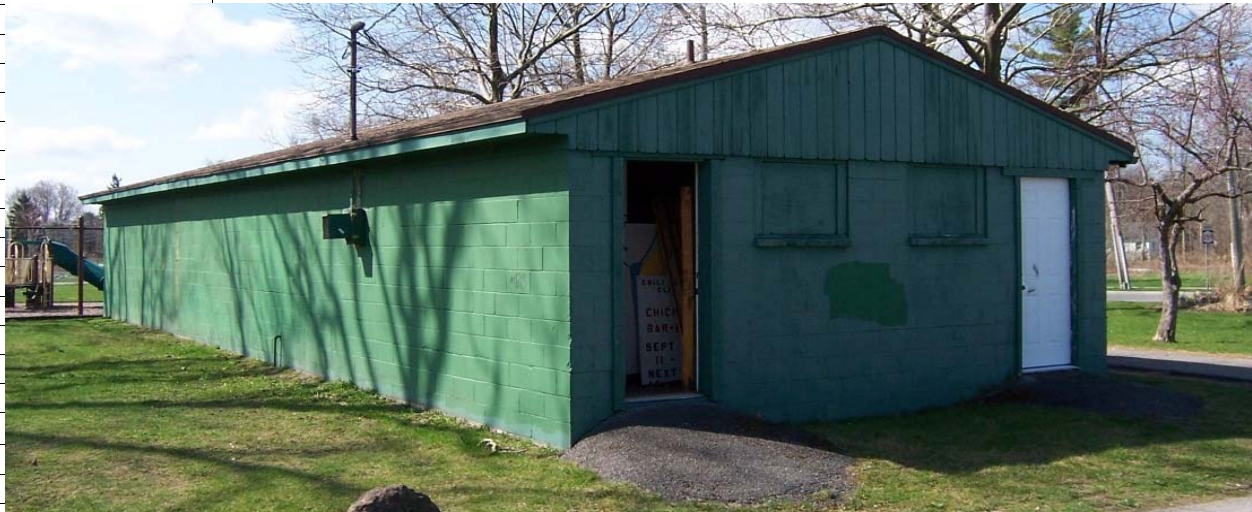
Date	4/25/2013
Park	Hubbard Park
Structure	Lion's Storage Facility
Year constructed	1960 - 70's?
Arch. significant	NA
No. of stories	One
Sprinklers	NA
Gross SF +/-	1,215 S.F.
Plans available	No
Exterior wall type	Concrete block painted
Structural system	Masonry wall with wood trusses
Found. / floor slab	Concrete floor
Roof	Asphalt shingles starting to show age, will need to be replace in the next 5 years. No gutters
Soffits / cornice	Wood painted
Interior finishes	Painted block walls; Gypsum board ceilings; coated panels at toilet rooms
Plumbing	Removed from toilets, didn't observe any in storage, assume there may be one sink.
HVAC	Assume yes, did not view. Gas Service
Electrical	Yes
Stairs and railings	NA
Doors	Metal doors, residential grade
Windows	removed and filled with plywood panels
Chimneys	NA
Energy utilization	year round, low use
Handicapped access	No
Toilet facilities	All plumbing fixtures have been removed and rooms are used for storage. Vandalism primary reson for closing toilets.

General repair notes	Need standard maintenance
Condition rating	fair to good
Proposed improvement	Consider reinstating toilets, will require modfication and build up of grade at doors to be accessible.

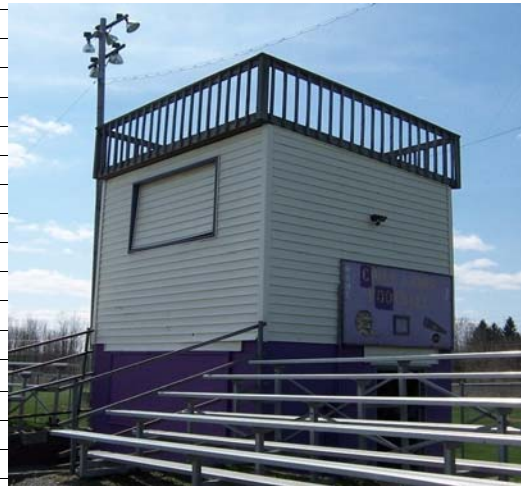
Date	4/25/2013
Park	Memorial Park
Structure	Concessions and Press Box Building
Year constructed	
Arch. significant	NA
No. of stories	two with a roof deck
Sprinklers	NA
Gross SF +/-	14' x 12'-8" = 355 S.F.
Plans available	No
Exterior wall type	First Level-masonry block painted; Second level-wood studs w/ vinyl siding; no insulation(assumed)
Structural system	First Level-Masonry block; Second level wood frame with wood roof joists (flat)
Found. / floor slab	Concrete floor - significant slope to the center of space (assumed floor drain, covered by equip.)
Exterior sidewalk	Has significant settlement cracks; step to grade - trip hazard
Roof	Rolled Asphalt (assumed); Water damage present at underside, assume repair/replacement required. Wood railing on all 4 sides, appears in good condition, assume that the height is probably 36".
Soffits / cornice	NA
Interior finishes	Painted block and wood paneling. Unfinished roof rafters and plywood deck mold is evident on the underside of the roof deck, assume its related to roof condition. Driving rain appears to get in through large openings that have a panel that cises them off.

Plumbing	One three bay sink, small hot water tank
HVAC	Propane tank for equipment located outside in locked storage; No heat or AC
Electrical	Yes
Stairs and railings	Site made ladder of metal angles for roof access.
Doors	Metal, could use replacement
Windows	NA
Chimneys	Exhaust hood for grill
Energy utilization	Limited; seasonal
Handicapped access	No
Toilet facilities	None
Kitchen Equipment	one griddle, one three bay sink, one exhaust hood
General repair notes	Roof and deck need replacement; railing guard is not to code Number of sinks is not up to code
Condition rating	Fair
Proposed improvement	When roof is replaced, railing should be upgraded as well. Kitchen equipment is not up to code, so it could remain as is until major repairs are made. Space is limited.

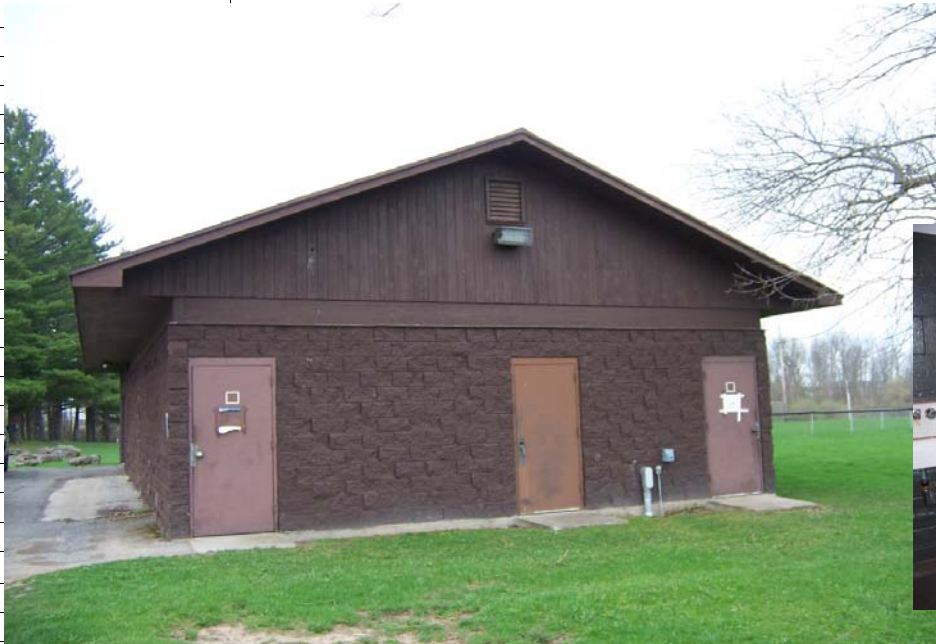
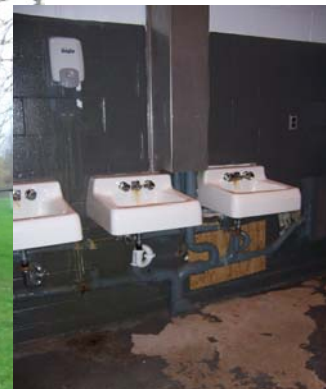
Date	4/25/2013
Park	Memorial Park
Structure	Toilet Building / Pee Wee Football Storage
Year constructed	
Arch. significant	NA
No. of stories	One
Sprinklers	NA
Gross SF +/-	
Plans available	No
Exterior wall type	Split face block painted
Structural system	Masonry wall with laminated beam; wood trusses
Found. / floor slab	Concrete floor - exposed in storage, painted in bathrooms, needs repainting
Roof	Asphalt shingles
Soffits / cornice	Wood stained, all should be restained including wood siding at pediment.
Interior finishes	Painted block walls, painted plywood ceilings in grid
Plumbing	Plumbing chase, all porcelain fixtures; piping to sinks is exposed
HVAC	Electric units mounted at top of walls
Electrical	Yes, Fluor. lights
Stairs and railings	NA
Doors	Metal doors painted
Windows	NA
Chimneys	NA
Energy utilization	Limited to electric; seasonal
Handicapped access	No for toilets. - path to rooms, doors into, signage and stalls don't comply.

Toilet facilities	At sessions building which is nearby
General repair notes	Need standard maintenance Stain all wood components to freshen up appearance.
Condition rating	fair to good
Proposed improvement	Renovate toilet rooms: for H.C. access. Provide new exhaust fans, repaint lighter color, utilized energy efficient fixtures. Provide exterior signage, replace doors. Consider adding light tubes for natural light at toilets?

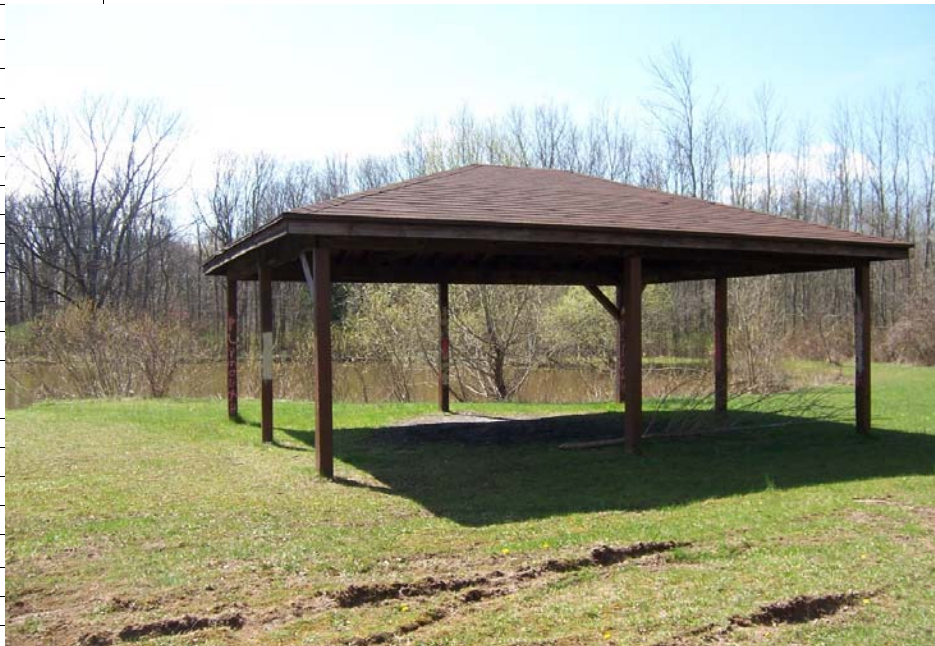
Date	4/25/2013
Park	Nature Trail Area
Structure	Pavilion
Year constructed	
Arch. significant	NA
No. of stories	One
Sprinklers	NA
Gross SF +/-	250 S.F. approximation
Plans available	No
Exterior wall type	None
Structural system	Wood posts with wood framed roof
Found. / floor slab	Concrete - good, footers for columns all are cracking, one is completely gone, another is breaking apart
Roof	Asphalt Shingles fair to good
Soffits / cornice	Wood stained, all should be restained with opaque stain
Interior finishes	NA
Plumbing	NA
HVAC	NA
Electrical	mounted on a board outside the pavilion
Stairs and railings	NA
Doors	NA
Windows	NA
Chimneys	NA
Energy utilization	Limited to electric; seasonal
Handicapped access	Good, from parking over lawn, no walkway fairly level.
Toilet facilities	At sessions building which is nearby
General repair notes	Building is stable, just need standard maintenance Graffiti is an issue due to remote location

Condition rating	fair to good
Proposed improvement	Stain all wood components to freshen up appearance.
	Consider concrete floor

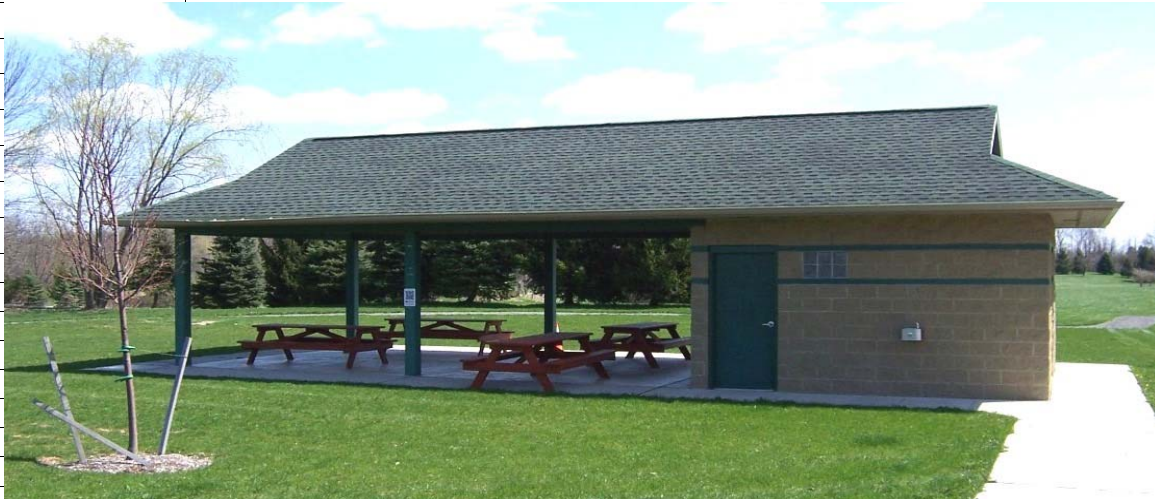
Date	4/25/2013
Park	Widener Park
Structure	Pavilion and Toilet Building
Year constructed	2009 +/-
Arch. significant	NA
No. of stories	One
Sprinklers	NA
Gross SF +/-	Enclosed: Approximately 24' x 16' = 384 S.F. Pavilion: Approximately 24' x 32' = 768 S.F.
Plans available	Assume yes
Exterior wall type	Split face masonry block; no insulation (assumed)
Structural system	Masonry block with wood columns and wood framed roof
Found. / floor slab	Concrete floor
Roof	Asphalt shingles
Soffits / cornice	Wood painted
Interior finishes	Painted block. Rough sawn plywood painted at pavilion. Painted drywall ceilings in toilets.
Plumbing	Yes. Toilets, sinks and drinking fountain.
HVAC	NA
Electrical	Yes
Stairs and railings	NA
Doors	Metal painted
Windows	Glass block at toilets
Chimneys	NA
Energy utilization	Limited; seasonal
Handicapped access	Yes
Toilet facilities	Yes. Two separate toilet rooms are handicapped accessible.
General repair notes	Repair damaged to the gutter (minor appears that someone pulled on it) Paint on doors on south side is caulking

Condition rating	Excellent
Proposed improvement	NA
